# Portage Creek Sediment Remediation Project Kalamazoo, Michigan

Pre-Sediment Removal Structure Feature Assessment  
Removal Areas SA3-A, SA3-B and SA3-Access

F&V Project Number: 809930

August, 2012

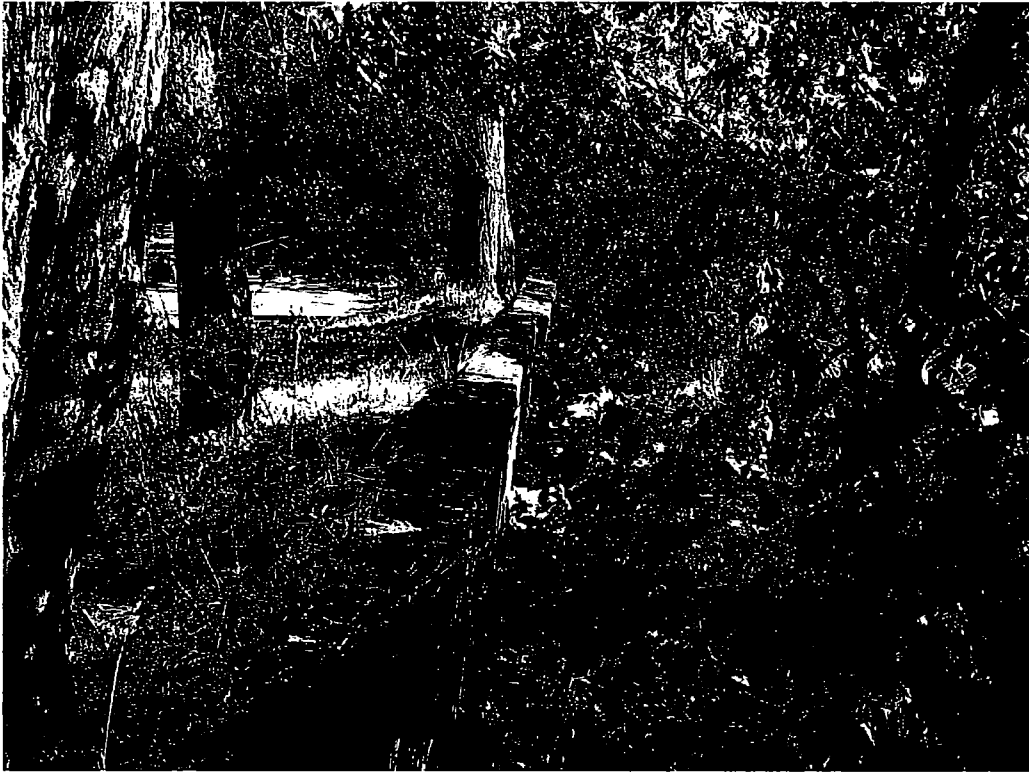
- The concrete retaining wall is in poor condition, leaning in several locations. There are several severe to critical vertical cracks in the wall. Growth of a large tree behind the wall has caused ~2" offset at one of the cracks.
- The parking lot is newer concrete paving.

Critical vertical crack and leaning section of retaining wall at tree growth

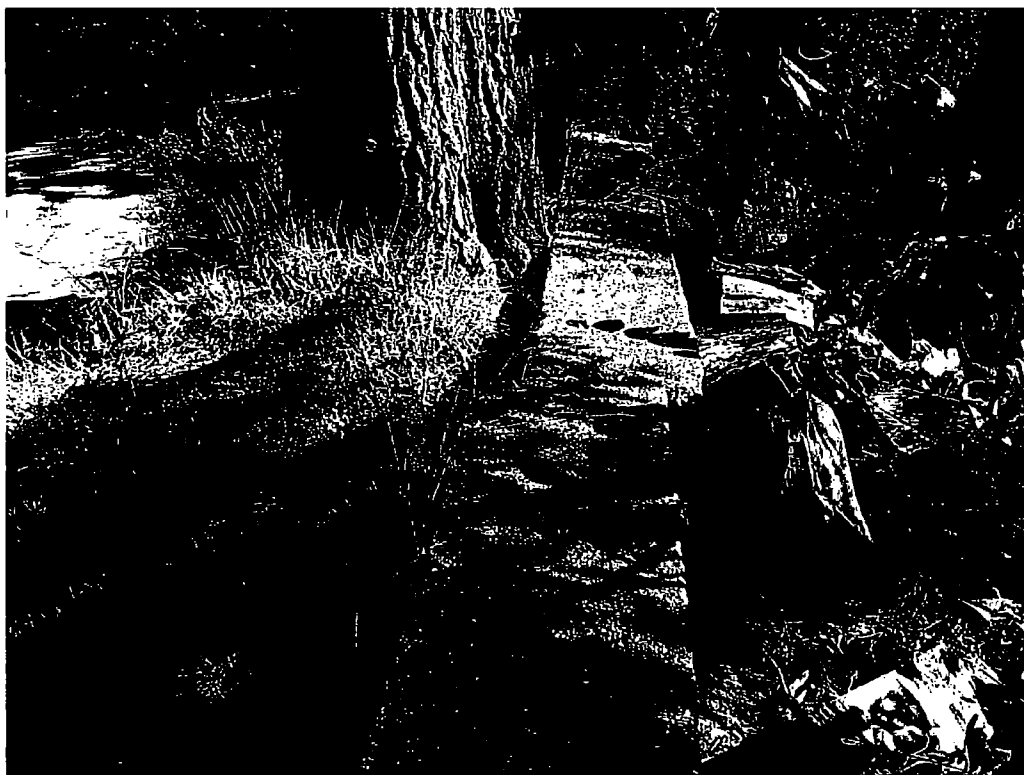
Critical cracking and leaning of wall at tree growth

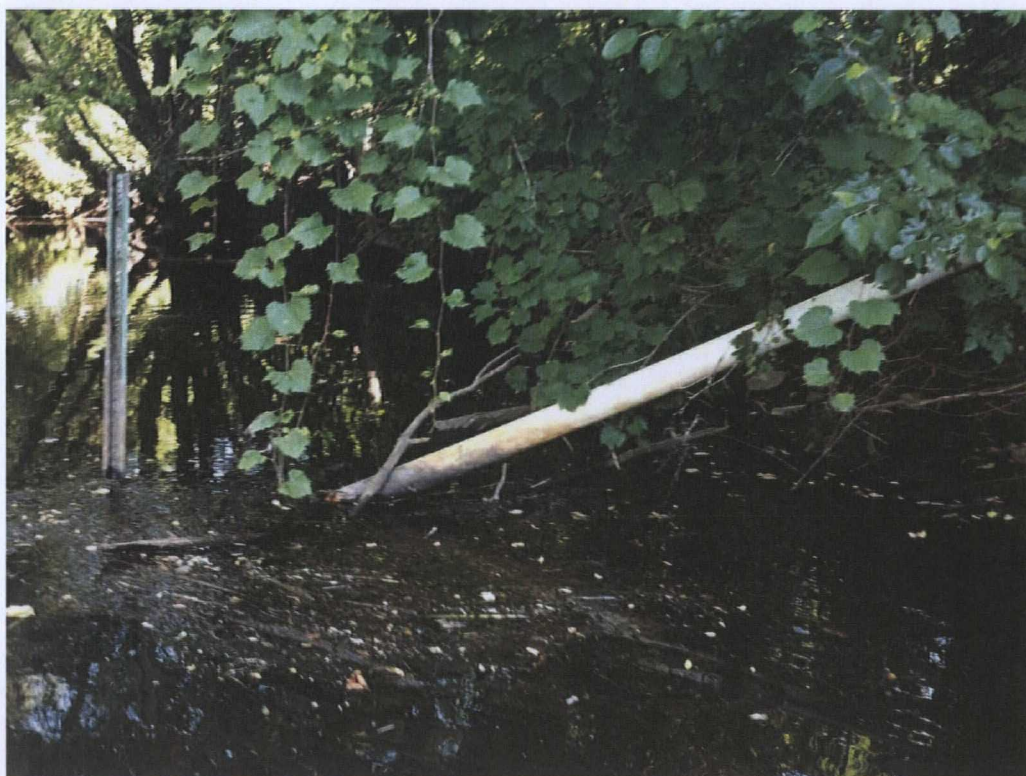
- There is moderate corrosion on the steel post in the channel.
- The PVC sampling tube is not connected to the unit at the top of the bank.

View of PVC sampling tube from south channel

- Coordinate with the City to remove and replace the structure if required for sediment removal.
- Identify the structure to operators and drivers with construction fencing or similar during the work.

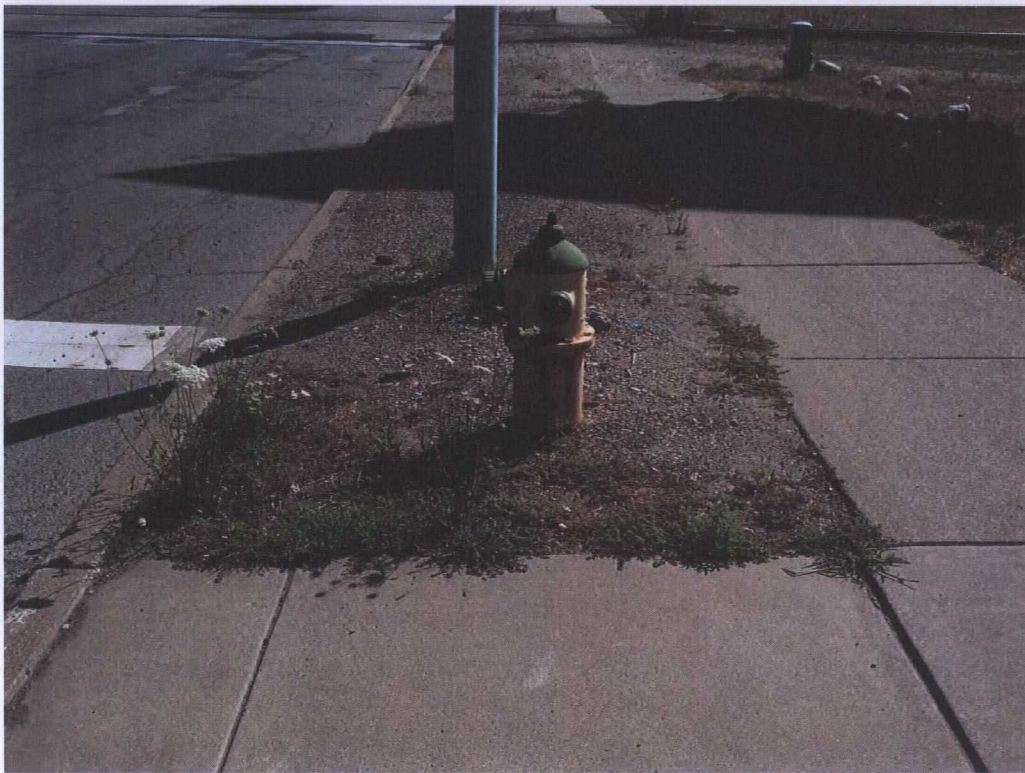
- The fire hydrant is in fair condition, with paint flaking and minor surface corrosion.

View of box looking east showing corrosion

- The hydrant should be identified/protected with construction fencing or similar during the work.

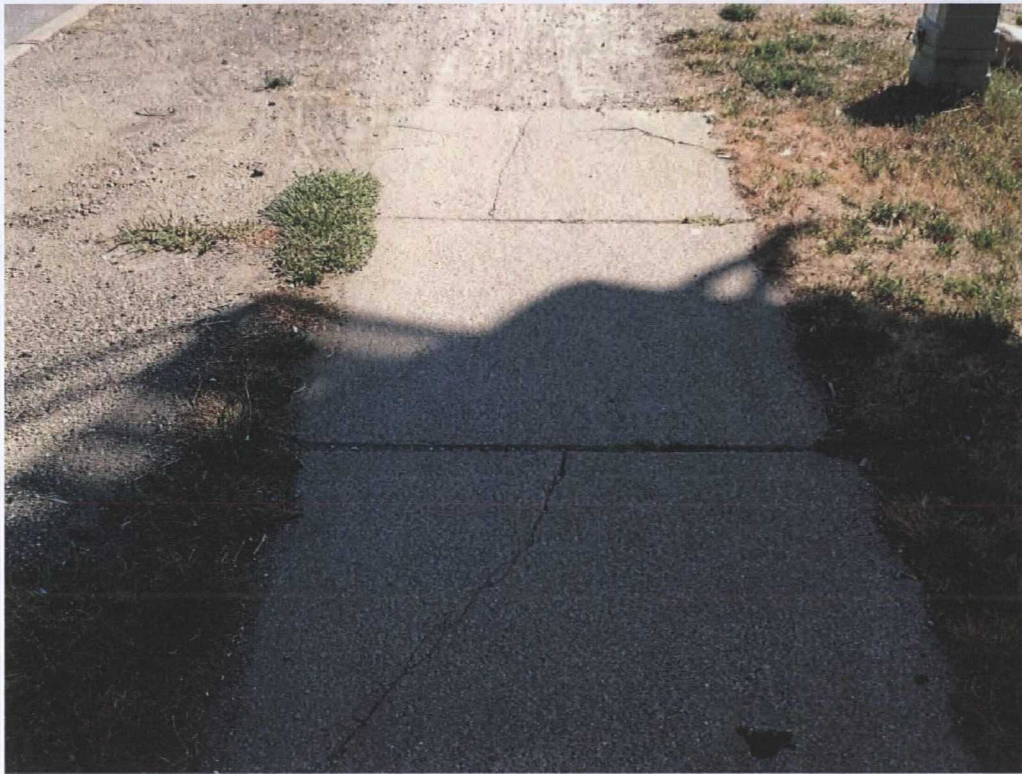
- The east flag and 3<sup>rd</sup> from east flag of concrete have moderate cracking.

Cracking in the east flag and 3<sup>rd</sup> from east

- The existing sidewalk is likely not intended for trucking loads and will likely crack and spall during the work. Damaged sections should be removed and replaced in kind.

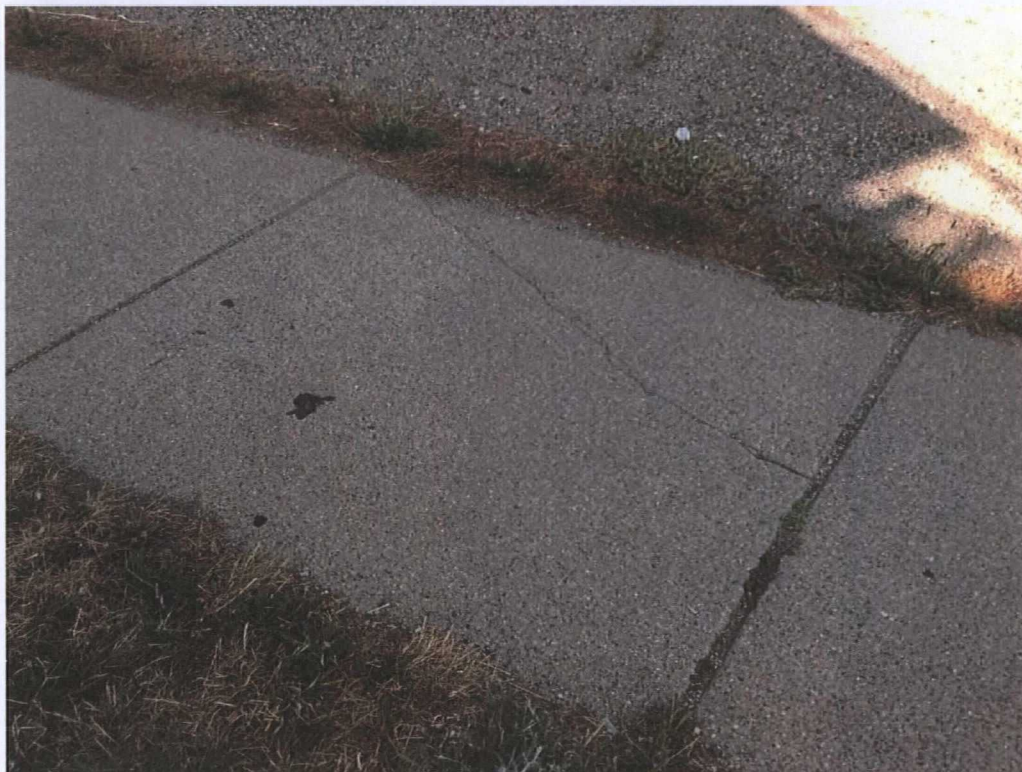
Cracking in the 3<sup>rd</sup> flag of sidewalk from the east

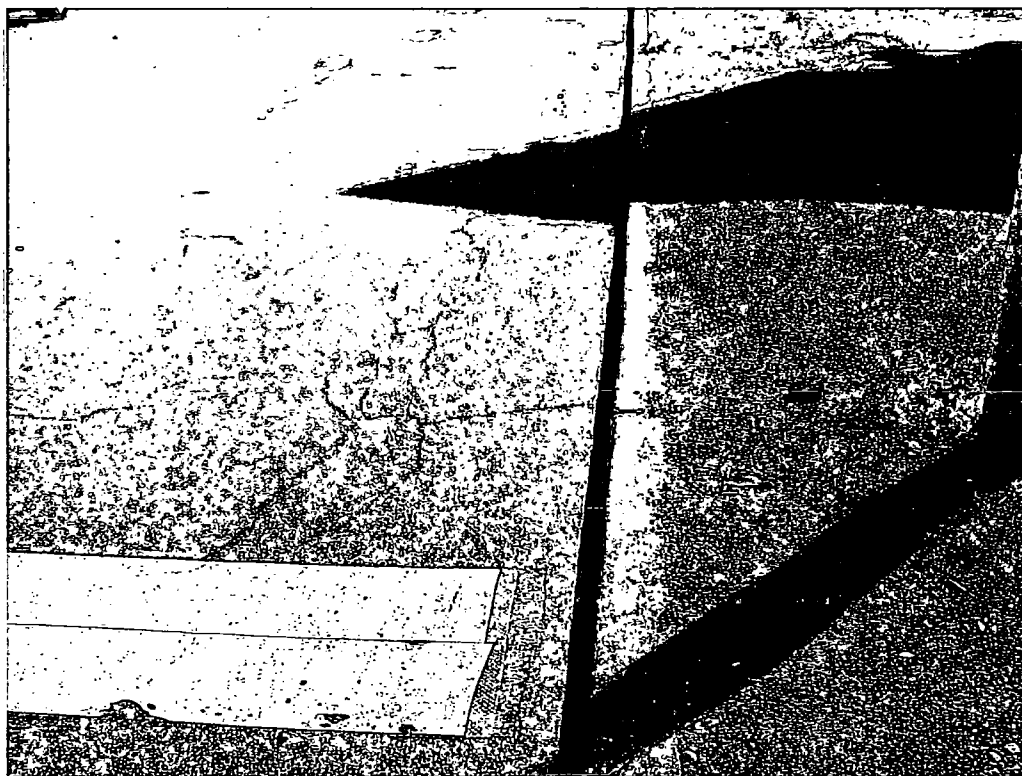
- Asphalt pavement has been treated with chip seal. Severe cracking was noted in the pavement.
- The curb pan has been overlaid during subsequent paving operations.
- Scattered cracking and spalling was noted near the railroad stop bar.

Alligator cracking in asphalt pavement

- Repair asphalt pavement and/or concrete curb and gutter if damaged during the work.

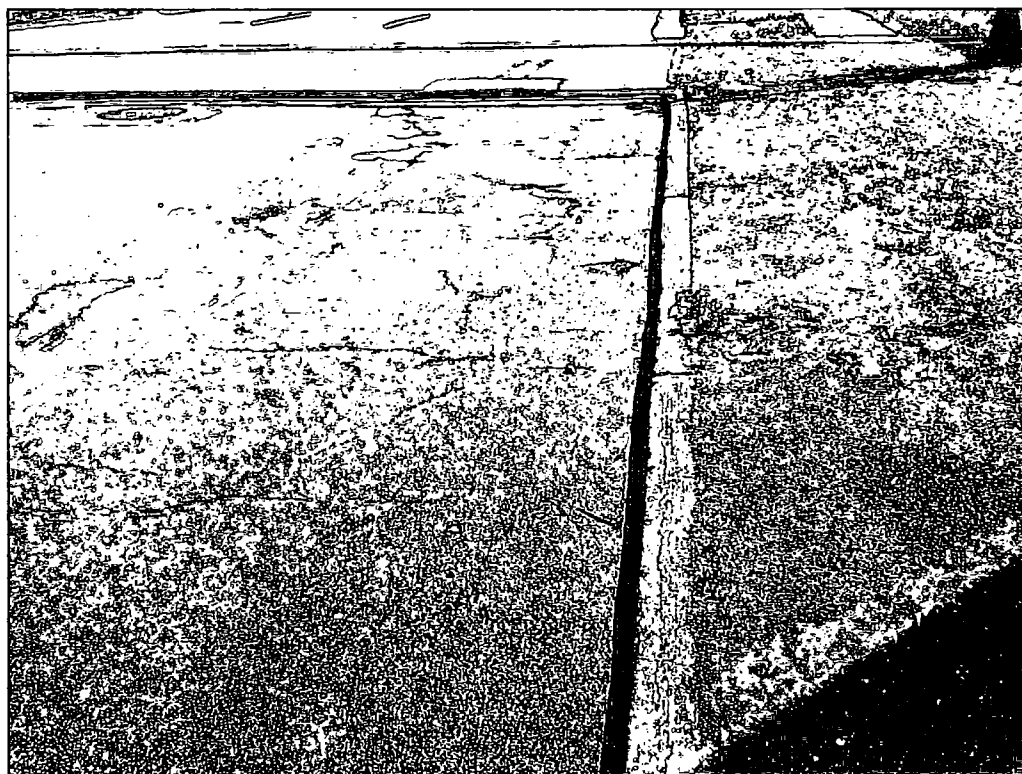
Block cracking and cold patch in asphalt pavement

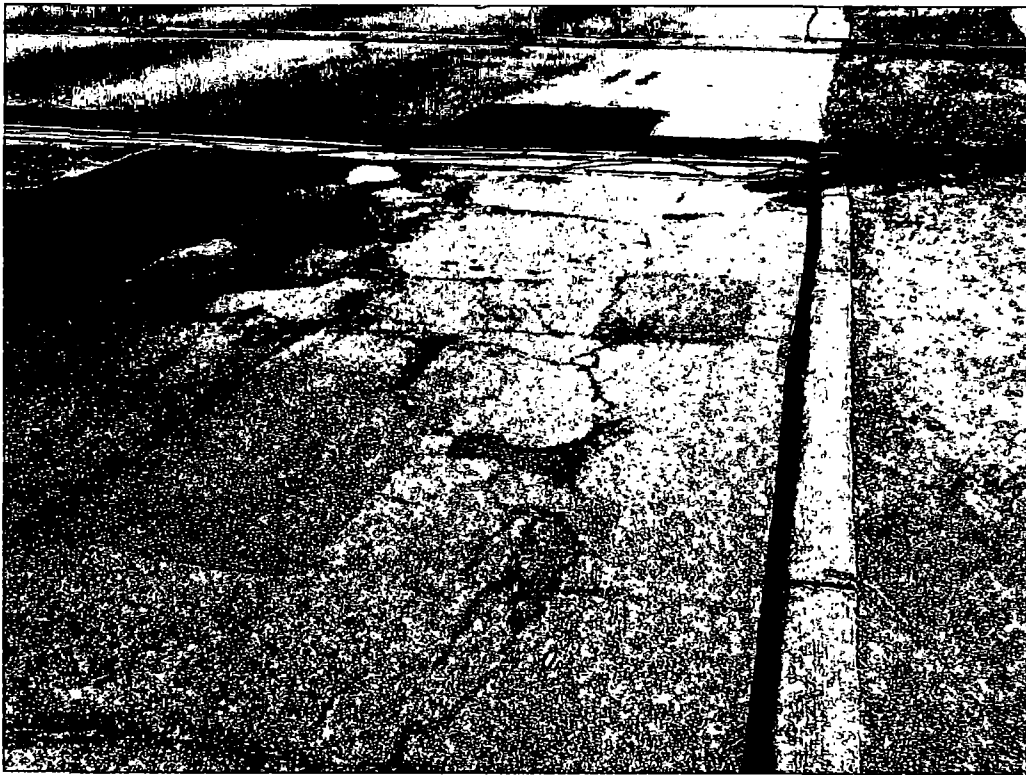
Block cracking and cold patch in asphalt pavement

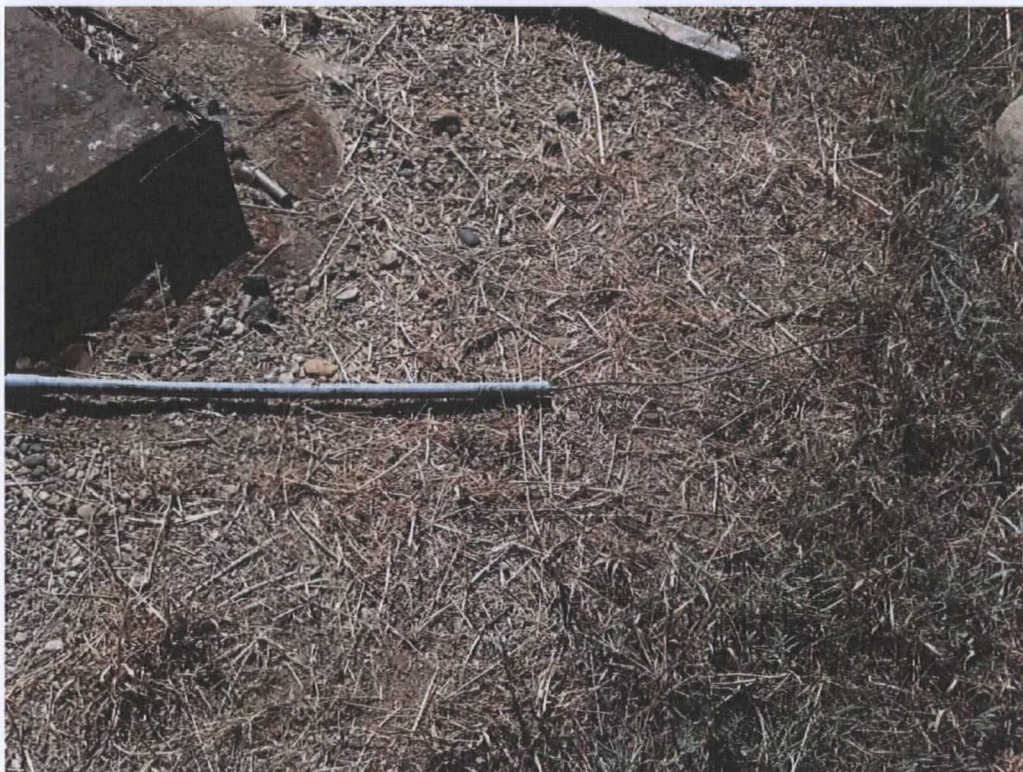
- The steel column has minor scrapes and flaking paint.
- There is an electric service panel on the west side mounted on a timber panel. One of the box covers is loose.
- The electric conduit extending to the southwest is loose.
- The grounding rod is exposed and loose.
- The exposed concrete pedestal has hairline cracking and isolated spalling.

Loose conduit and exposed wire extending to the southwest

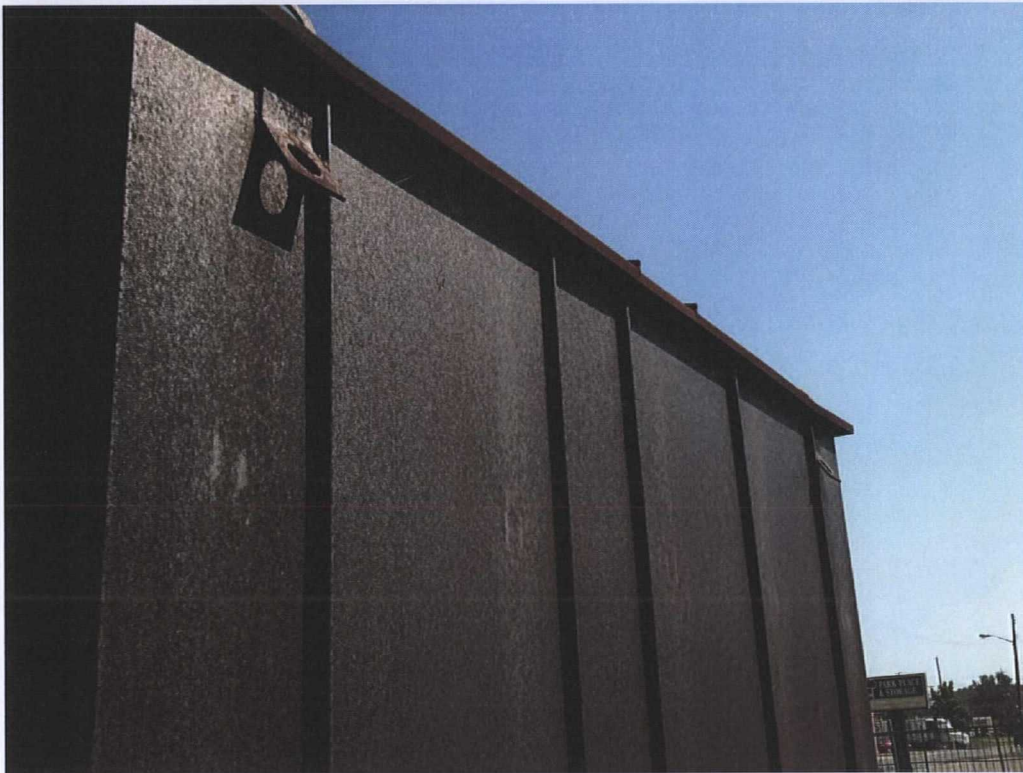
- The siding has moderate to severe surface corrosion.
- There is a sink hole under the northwest corner.
- There is an electric service panel on the west wall.

Surface corrosion on side of shed

- The shed structure should be identified/protected with construction fencing or similar during the work.
